**DEPARTMENT OF TRANSPORTATION**

Contract #: 04-0120F4Cty: SF/ALA Rte: 80 PM: 13.2/13.9File #: 1.28**WELDING INSPECTION REPORT****Resident Engineer:** Casey, William**Address:** 333 Burma Road**City:** Oakland, CA 94607**Report No:** WIR-028451**Date Inspected:** 18-Sep-2012**Project Name:** SAS Superstructure**OSM Arrival Time:** 700**Prime Contractor:** American Bridge/Fluor Enterprises, a JV**OSM Departure Time:** 1930**Contractor:** American Bridge/Fluor Enterprises, a JV**Location:** Job Site**CWI Name:** See below.**CWI Present:** Yes No**Inspected CWI report:** Yes No N/A**Rod Oven in Use:** Yes No N/A**Electrode to specification:** Yes No N/A**Weld Procedures Followed:** Yes No N/A**Qualified Welders:** Yes No N/A**Verified Joint Fit-up:** Yes No N/A**Approved Drawings:** Yes No N/A**Approved WPS:** Yes No N/A**Delayed / Cancelled:** Yes No N/A**Bridge No:** 34-0006**Component:** OBG**Summary of Items Observed:**

**OBG 12W**

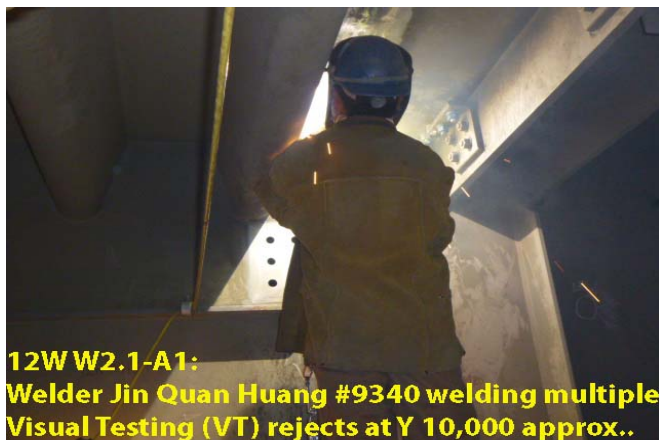
Welder Jin Quan Huang was observed welding and grinding on weld 12W W2.1-A1. The welder was observed utilizing Caltrans approved Welding Procedure Specification's (WPS) ABF-WPS-D15-1001-R and preheating the weld to the over 200 degrees Fahrenheit prior to weld. The areas welded were areas noted for visual surface porosity after the weld cap was ground smooth in preparations for Ultrasonic Testing Shear Wave (UTSW). Welder was observed welding as per Welding Procedure Specification's (WPS) noted above at Y location 3000 and 10000.

**12W W2.1-A1:  
Welder Jin Quan Huang #9340 welding multiple  
Visual Testing (VT) rejects at Y 10,000 approx..**

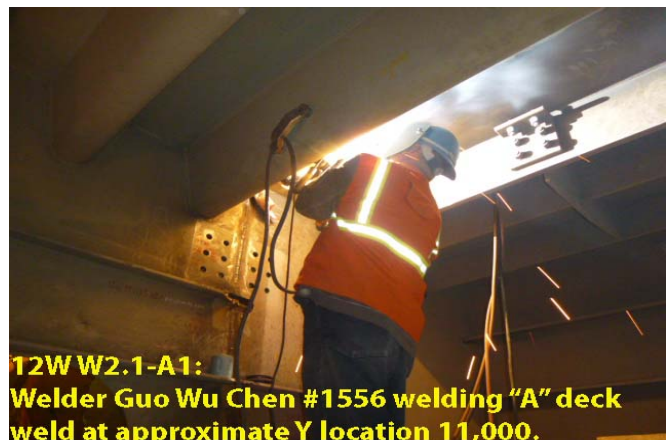
Welder Guo Wu Chen was observed welding and grinding on weld 12W W2.1-A1. The welder was observed utilizing Caltrans approved Welding Procedure Specification's (WPS) ABF-WPS-D15-1001-R and preheating the weld to the over 200 degrees Fahrenheit prior to weld. The areas welded were areas noted for visual surface porosity after the weld cap was ground smooth in preparations for Ultrasonic Testing Shear Wave (UTSW). Welder was observed welding as per Welding Procedure Specification's (WPS) noted above at Y location 13000.

**12W W2.1-A1:  
Welder Guo Wu Chen #1556 welding "A" deck  
weld at approximate Y location 11,000.**

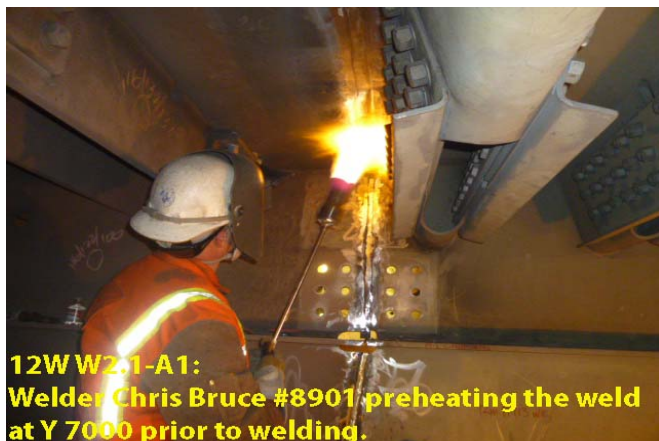
Welder Chris Bruce was also observed welding on weld 12W W2.1-A1. The welder was observed utilizing Caltrans approved Welding Procedure Specification's (WPS) ABF-WPS-D15-1010R; preheating to the specified temperature prior to welding. Welding parameters observed were as per Welding Procedure Specification's (WPS) noted above and appears to be in order.

**12W W2.1-A1:  
Welder Chris Bruce #8901 preheating the weld  
at Y 7000 prior to welding.**

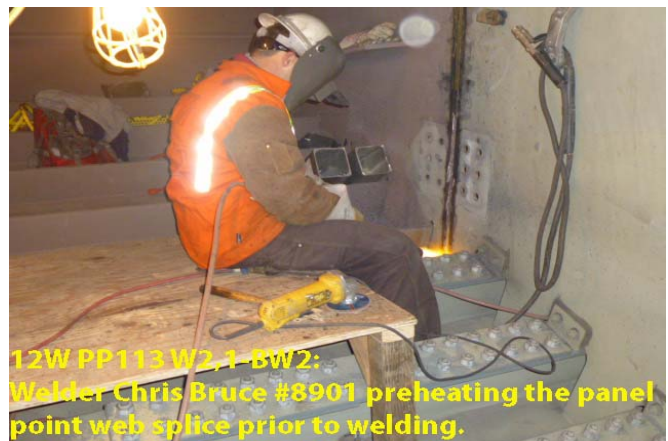
Welder Chris Bruce was observed welding on weld 12W PP113 W2.1-BW2 (3G, CJP). The welder was observed utilizing Caltrans approved Welding Procedure Specification's (WPS) ABF-WPS-D15-1030; preheating to the specified temperature prior to welding. Welding parameters observed were as per Welding Procedure Specification's (WPS) noted above and appears to be in order.

**12W PP113 W2.1-BW2:  
Welder Chris Bruce #8901 preheating the panel  
point web splice prior to welding.**
